**FRACTURE PERFORMANCE
OF NGV CYLINDER DESIGNS**

Transportation Development Centre
Safety and Security
Transport Canada

Powertech Labs Inc.

March 1998

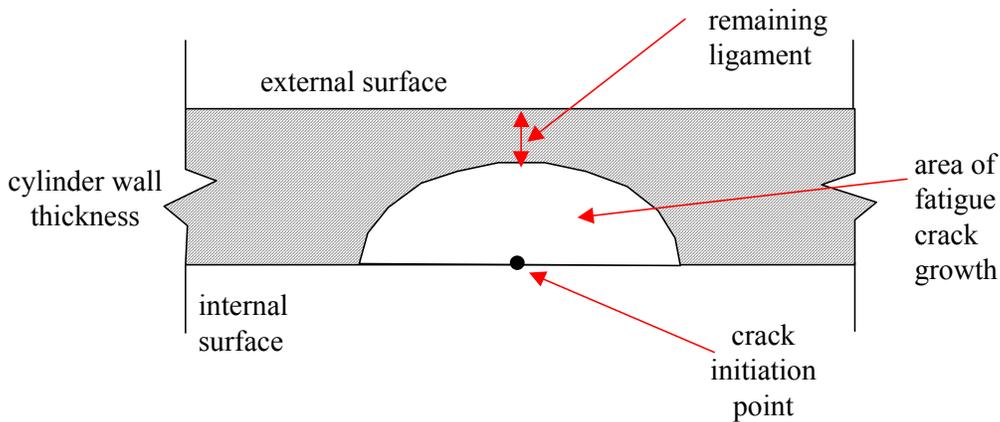
Figure 1: Shape of fatigue crack growing from the internal surface of a cylinder.

Fatigue cracks typically initiate on the inside walls of a cylinder (due to the fact that higher crack driving forces are often present on the inside surfaces of designs) and grow outward in a semi-elliptical shape (see Figure 1). A cylinder containing a fatigue crack would likely fail during a filling operation when the pressure would tend to reach a maximum.

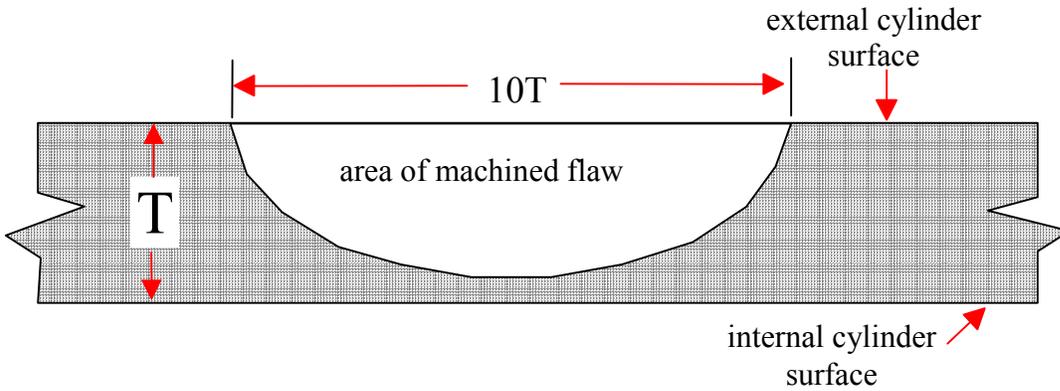
Figure 2a: Machined external flaw ($10T$ length) before hydraulic pressurization to failure.

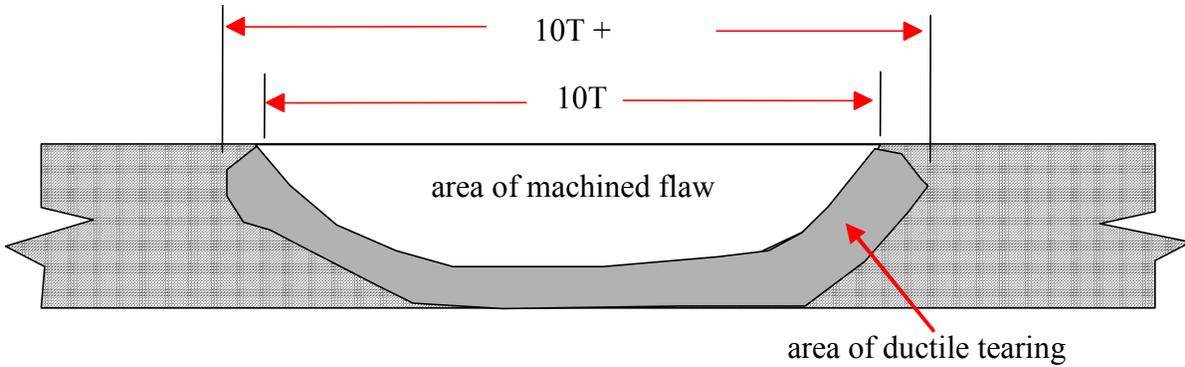
Figure 2b: After hydraulic pressurization to failure – the length of ductile tearing ($10T+$) beyond the machined flaw length ($10T$), indicating the cylinder would have ruptured if pneumatic pressure used.

It was found that the Taylor Wharton cylinder design containing a flaw of 10T length and of sufficient depth ruptured when pneumatically pressurized to 1.25 times its service pressure. In comparison, the same design with the same flaw size leaked when it was hydraulically pressurized to about the same pressure. Examining the fracture surface of the leak cylinder, it was found that the hydraulic pressurization had caused extension (ductile tearing) of the metal some 7% beyond the machined length of the flaw (see Figure 2b). This observations indicates that the results of a hydraulic burst test of a flawed cylinder could be used to predict the failure mode if compressed gas had been used instead.

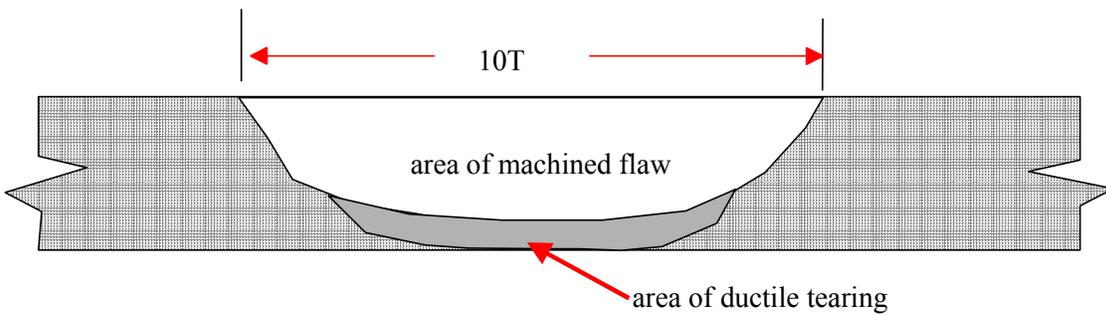
Figure 2c: After hydraulic pressurization to failure – the length of ductile tearing is less than the machined flaw length, indicating the cylinder would have leaked if pneumatic pressure used.

For the Faber cylinder design, cylinders containing flaws of up to 12.5T would leak when pressurized pneumatically to the maximum fill pressure. Faber cylinders containing the same flaw size also leaked when hydraulically pressurized to a similar pressure. In the hydraulic test, there was no evidence of any ductile tearing in the metal beyond the length of the machined flaw (see Figure 2c).

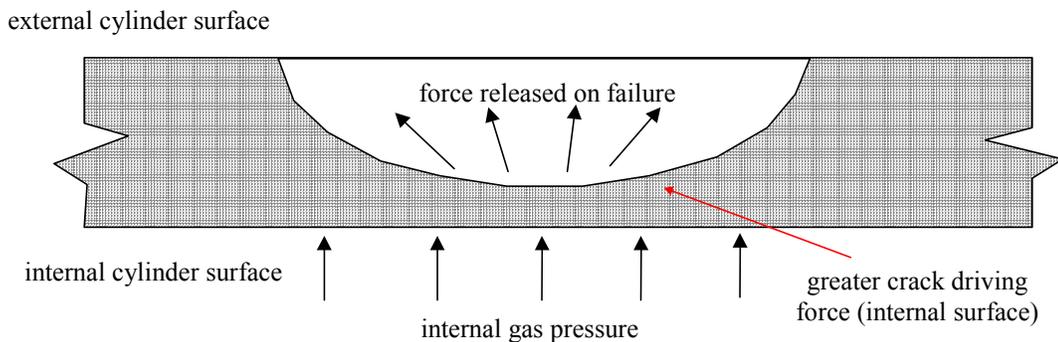
Figure 3a: Greater crack driving force associated with the failure of a flaw introduced on the external cylinder surface.

It was determined from Appendix C that the crack driving force is greater on the internal surface of a cylinder. As a result, an axial crack introduced into the external surface of a cylinder will have a greater crack driving force present on the remaining ligament (see Figure 3a) than the crack driving force that would be present on the remaining ligament of an axial crack introduced

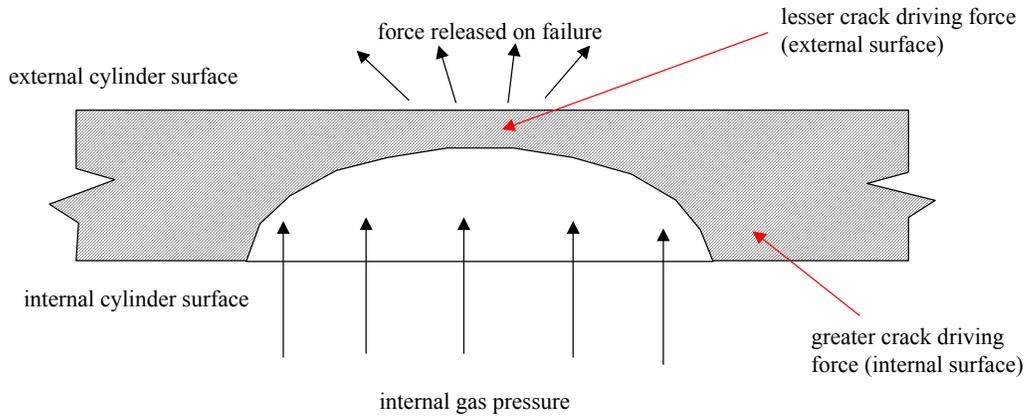
Figure 3b: Lesser crack driving force associated with the failure of a flaw introduced on the internal cylinder surface.

into the internal surface of a cylinder (see Figure 3b). Thus compared to an internal flaw, a greater force would be associated with the failure of an external flaw in a cylinder. Test results also indicate that if the length of a machined flaw in a cylinder increases during a hydraulic burst at or above the maximum fill pressure, the design would likely experience rupture under pneumatic burst conditions.

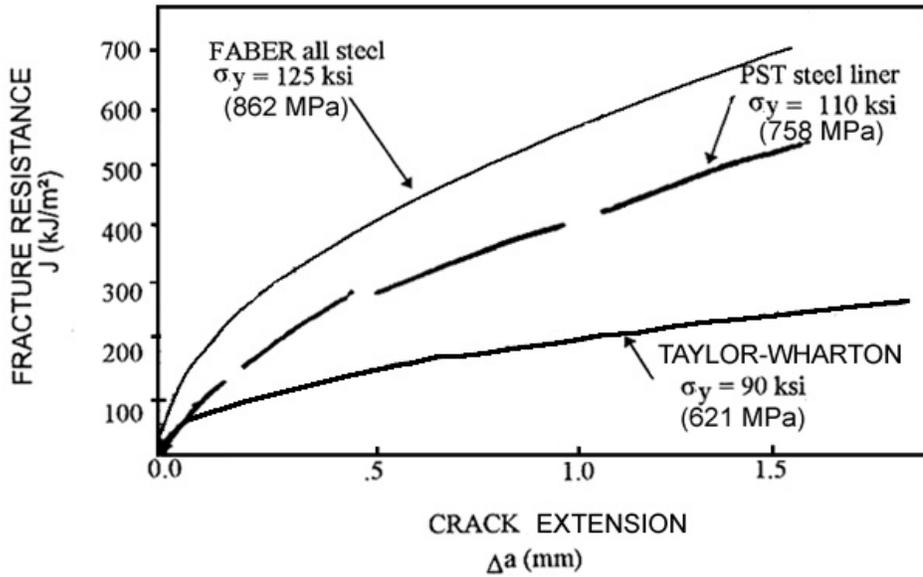
25n-1

Figure A-1: Fracture resistance of the steels of Type 1 cylinders and the Type 2 liner.

Figures A-1 and A-2 show the fracture resistance material properties (J-R curve) for the all-steel cylinder and the steel liner, and for the all-aluminum cylinder and the aluminum liner, respectively. Note the shape of the J-R curves shown in Figure 1. The curve for the Faber all-steel cylinder material is steeper than that of the Taylor-Wharton cylinder material, reflecting a tougher steel.

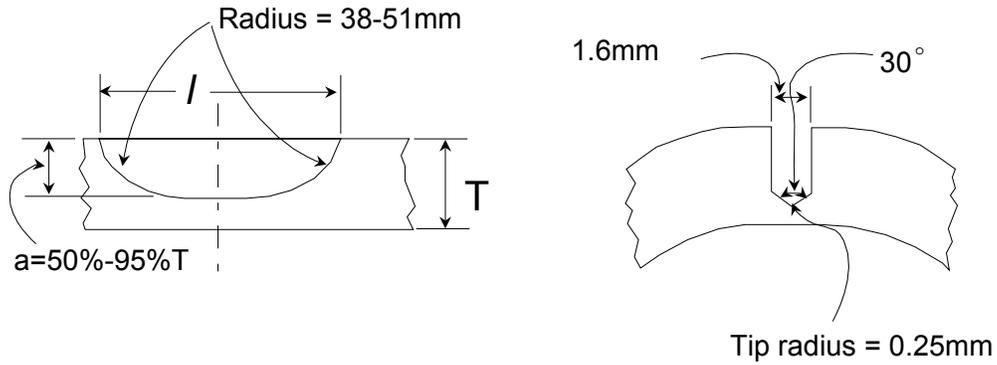
Figure A-3. Key parameter for the flaws machined onto the external surface of the cylinder using CVN cutter.

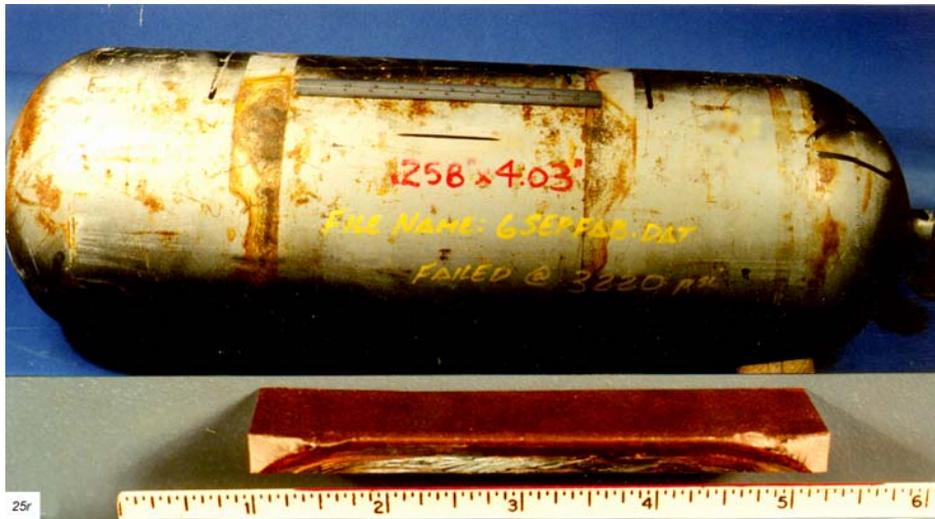
Figure A-4. Photograph shows location and cross section of machined flaw introduced onto the external surface of an all-steel Faber cylinder.

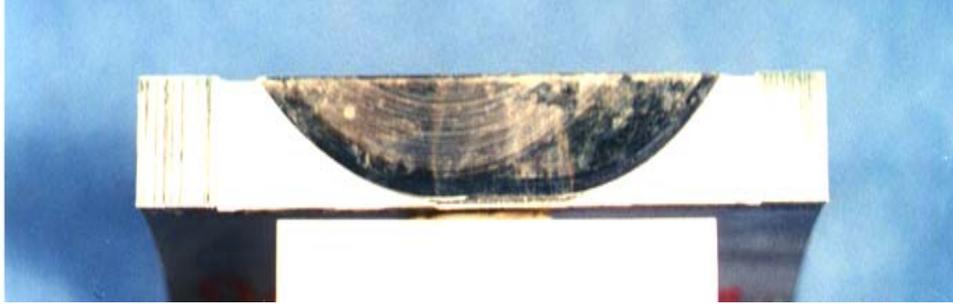
Figure A-5. Photograph shows cross section of an axial external machined flaw introduced onto.

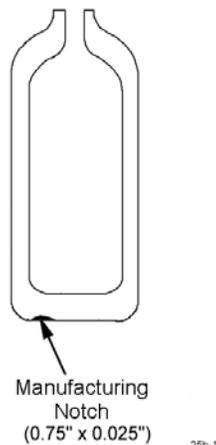
Figure A-6. Schematic of an all-aluminum (AA7032) Luxfer cylinder, showing the location of the manufacturing notch.

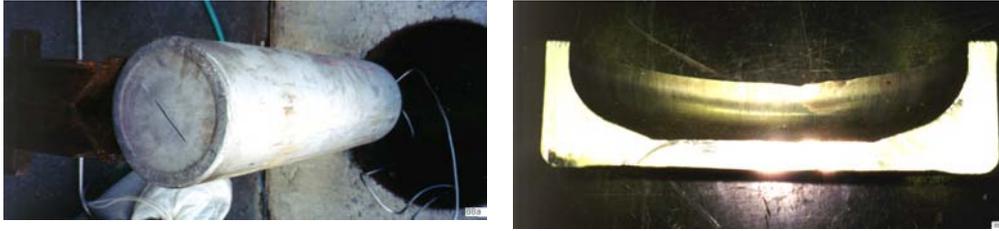
Figure A-7. Photograph shows location and shape of the external defect, machined onto the bottom of an all-aluminum (AA7032) Luxfer cylinder.

notch at the bottom was extended by machining using a CVN cutter. Figure A-7 shows the cross section of a machined defect at the bottom of an all-aluminum AA7032 Luxfer cylinder.

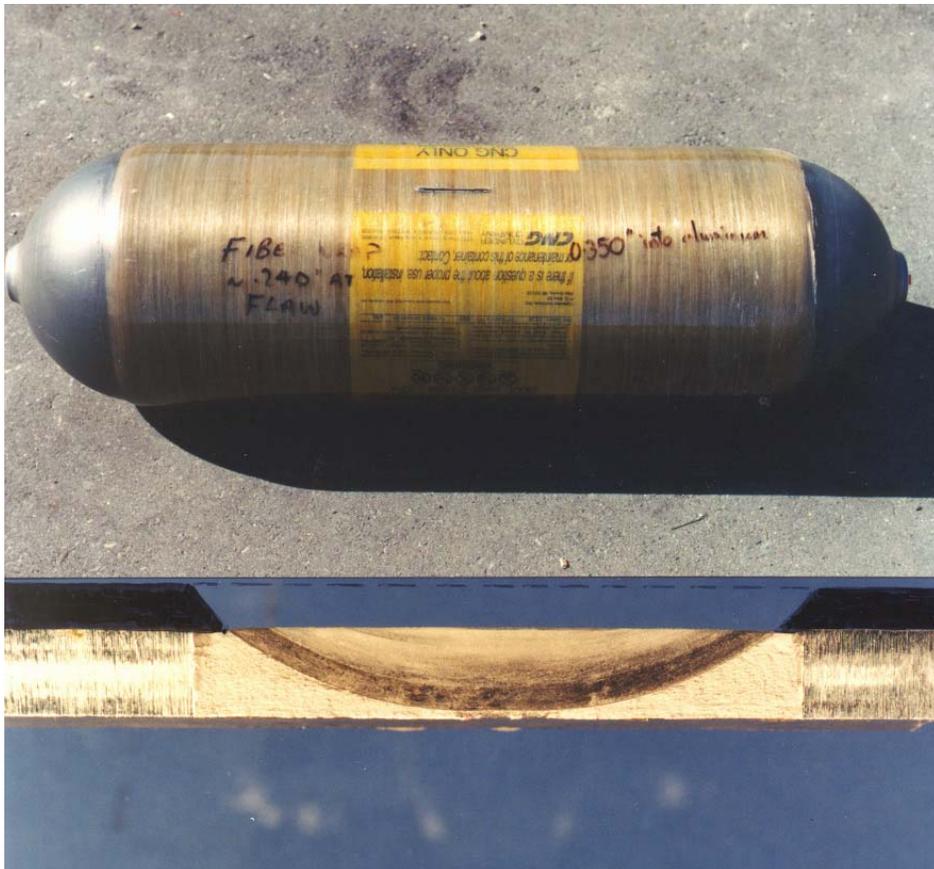
Figure A-8. Photograph showing location and cross section of a machined flaw introduced onto the external surface of an aluminum-lined hoop-wrapped (CNG Cylinder Co.) cylinder.

For Type 2 hoop-wrapped designs, deep axial defects were introduced onto the outer surface using the CVN cutter with a 30° angle. Cuts were made through the entire hoop wrap composite and extending into 80% of the liner wall. Figure A-8 shows a typical machined flaw for an aluminum hoop-wrapped cylinder.

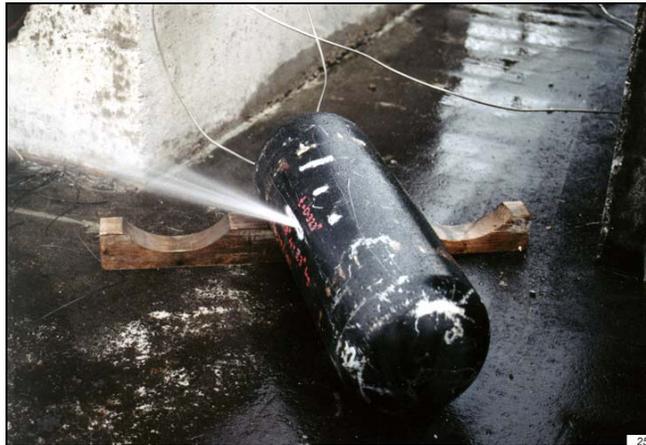
Figure A-9. An all-steel Faber cylinder with a 3.3" (84 mm) long axial flaw having a depth of approximately 80% of wall thickness leaked under a hydraulic pressure of 3,750 psi (25.85 MPa)

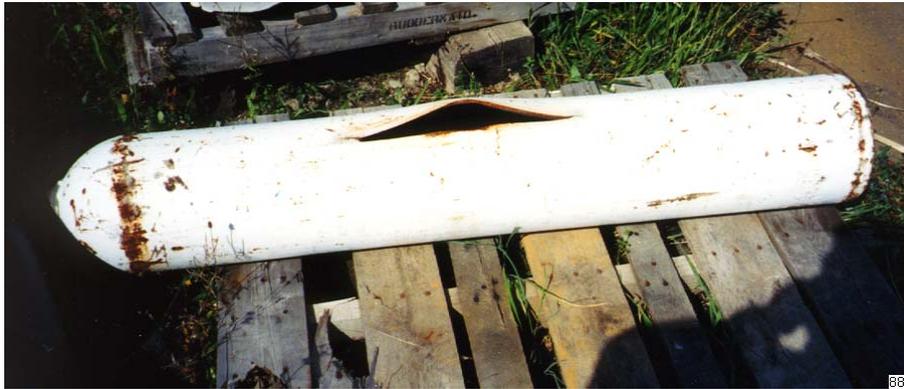
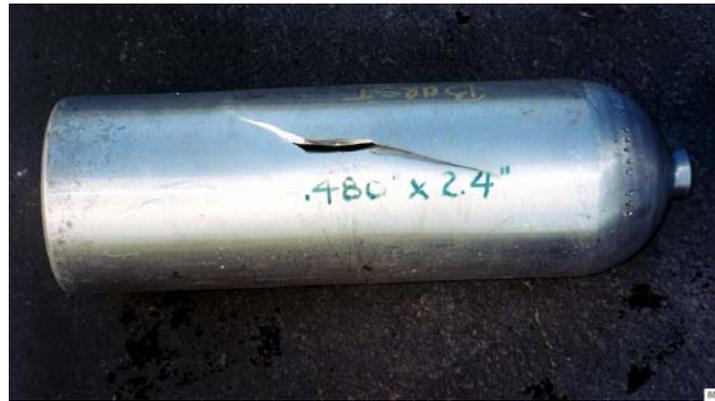
- (a) all-steel Taylor Wharton (long)*
- (b) all-aluminum Luxfer scuba cylinder*

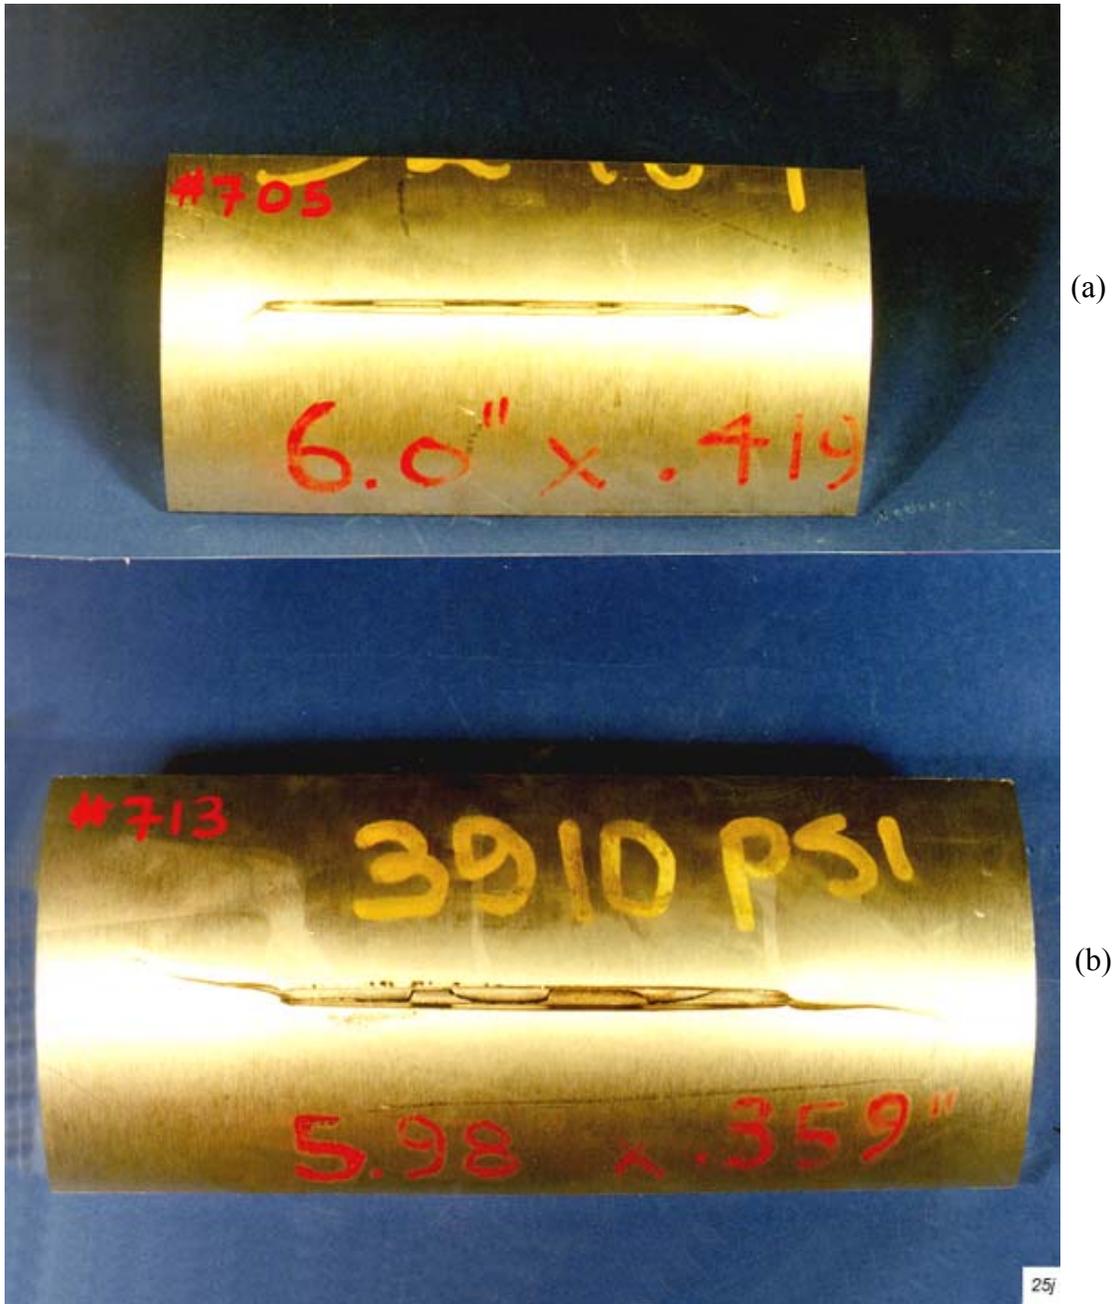
Figure A-11. Figures show the extension of the machined flaw along the length of the all-aluminum (AA6061-T6) Luxfer cylinders, observed during the hydraulic flawed cylinder burst tests:
(a) cylinder having a flaw (9.6T long and 67%T deep) failed at 3,240 psi (22.3 MPa)
(b) cylinder having a flaw (9.6T long and 57%T deep) failed at 3,910 psi (27.0 MPa).

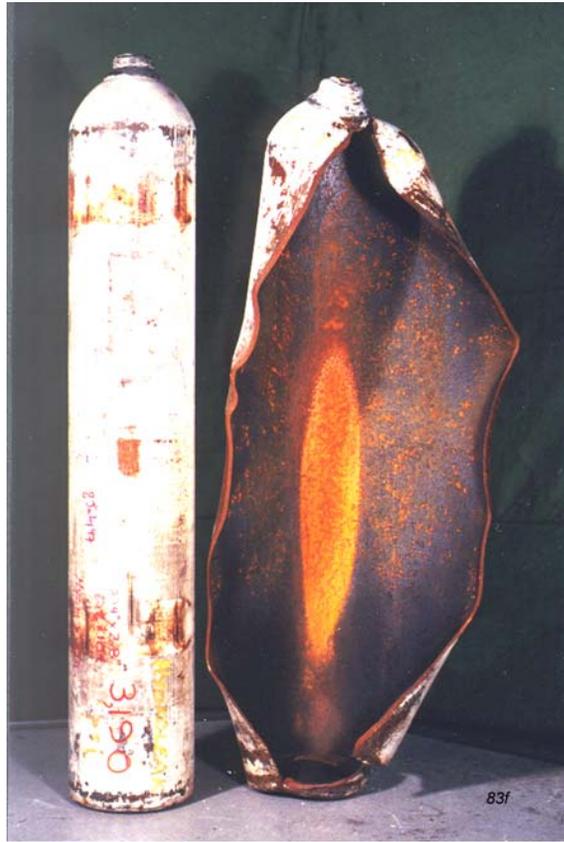
Figure A-12. Effect of medium of pressurization on the failure mode of long all-steel Taylor Wharton containing a 10T long machined flaw:
(a) cylinder having a flaw 83%T deep leaked under hydraulic pressurization
(b) cylinder having a flaw 80%T deep ruptured under pneumatic pressurization

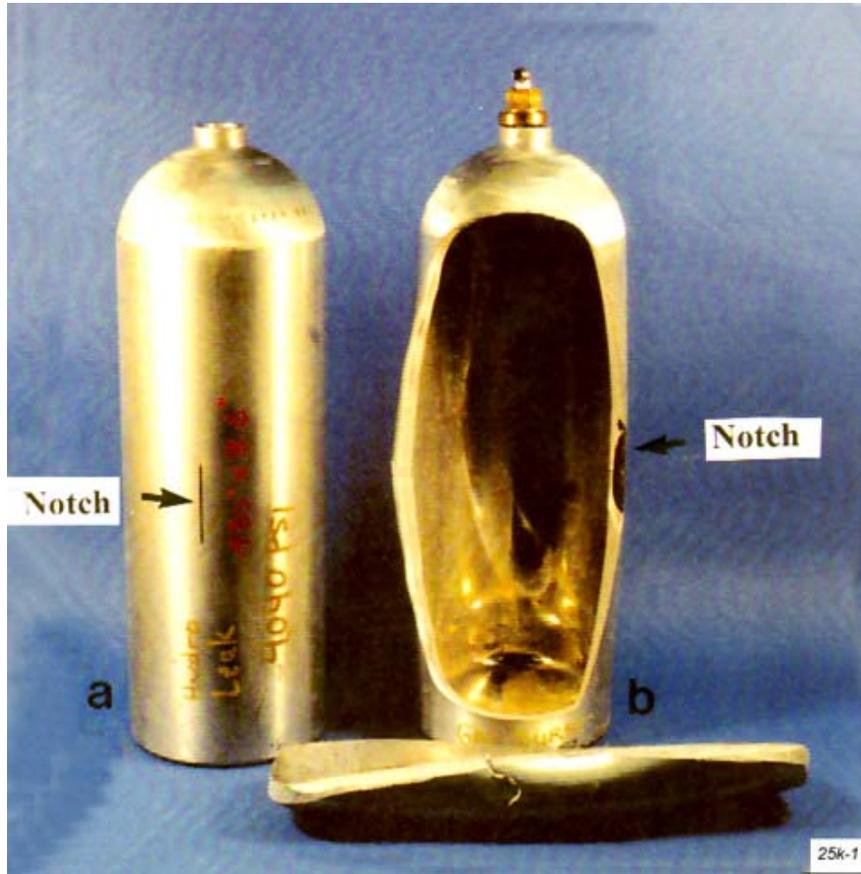
Figure A-13. Effect of medium of pressurization on failure mode of all-aluminum (AA6061-T6) Luxfer cylinders containing 6T long and 80%T deep axial external machined flaw:
(a) cylinder leaked under hydraulic pressurization
(b) cylinder ruptured under pneumatic pressure.

The above scenario probably also applies to aluminum cylinders. For example, an all-aluminum cylinder shown in Figure A-13a leaked in hydraulic pressurization. Another cylinder with a similar crack, pressurised with air, ruptured into three pieces, as shown in Figure A-13b. Although the cylinder leaked under hydraulic pressurization, ductile tearing was evident from the machined notch during the test. The extent of tearing around the machined notch during hydraulic pressurization testing of the flawed cylinder is shown in Figure A-16, along with the fractured surface of the leak. Maximum tearing of 5.7% beyond the length of the machined flaw was observed.

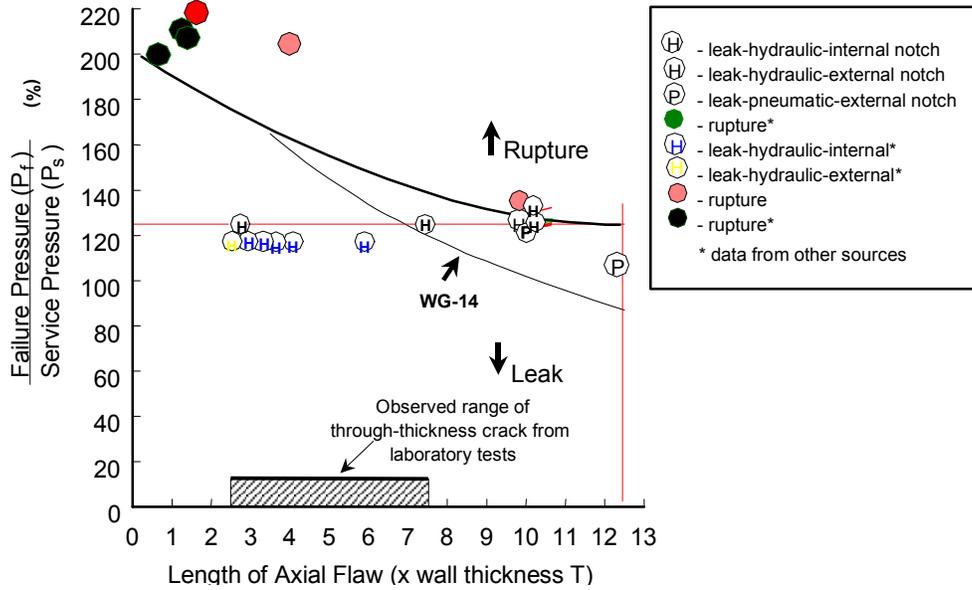
Figure A-14: Flaw tolerance of all-steel NGV cylinders

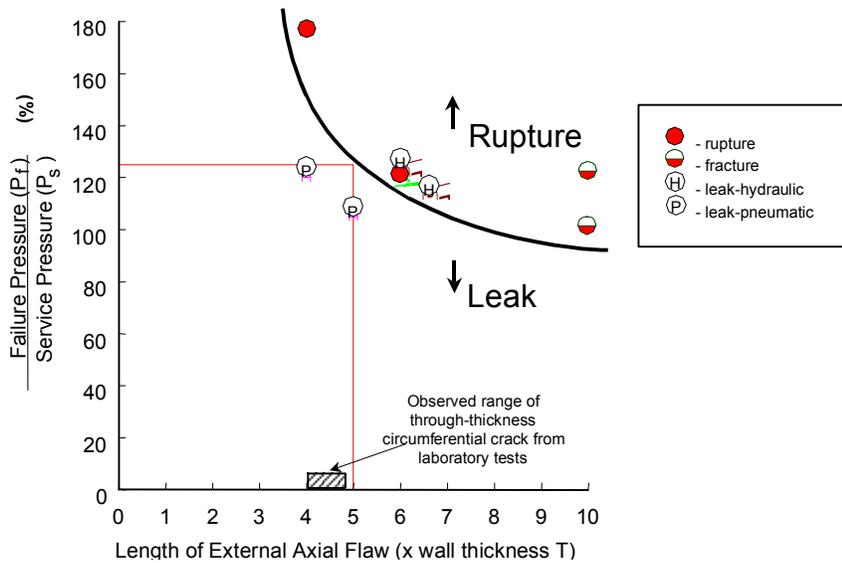
Figure A-15: Flaw tolerance of all-aluminum (AA6061-T6) cylinders

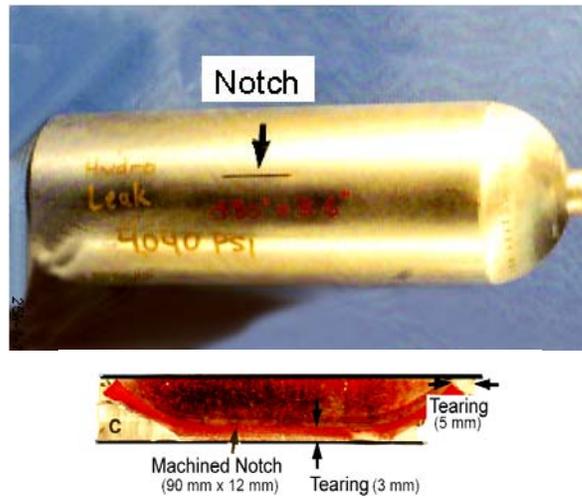
Figure A-16. Fracture surface of an all-aluminum (AA6061-T6) cylinder leaked under hydraulic pressurization. Photograph shows the ductile tearing of the machined defect during the hydraulic burst test.

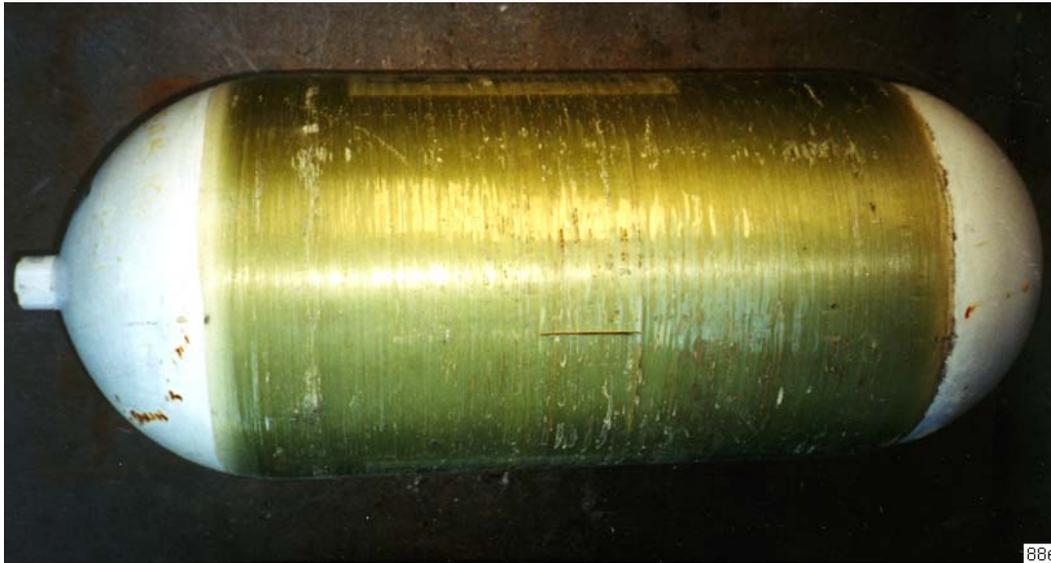
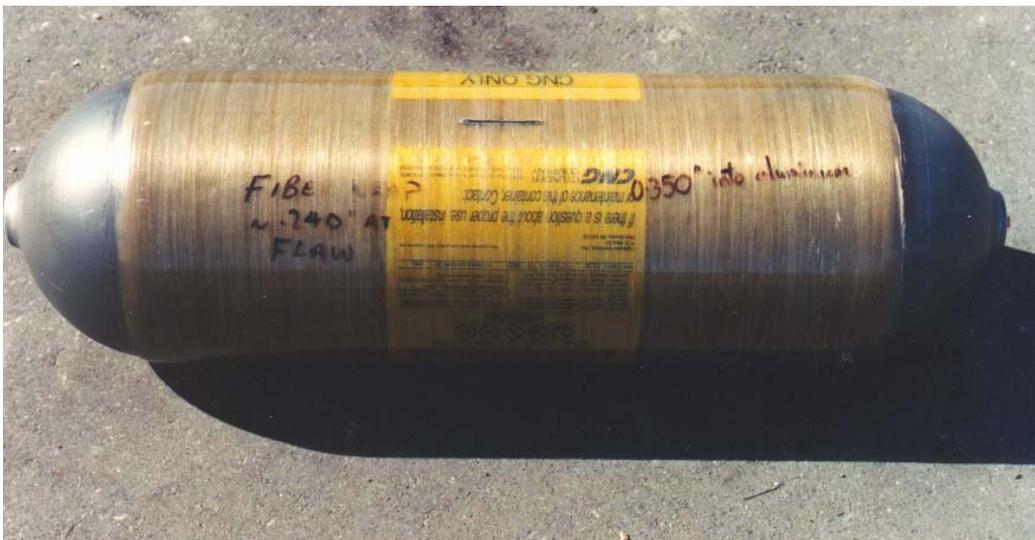
A steel-lined hoop-wrapped cylinder containing a 3.25 inch (83 mm) long machined cut through the entire composite and extending into 95% of the liner thickness leaked at a pneumatic pressure of 3,293 psi (22.7 MPa), as shown in Figure A-17a. An aluminum-lined hoop-wrapped cylinder containing a 2.8 inch (71mm) long machined cut through the entire composite and extending into 84% of the liner wall leaked at a pneumatic pressure of 3,410 psi (23.5 MPa), as shown in Figure A-17b.

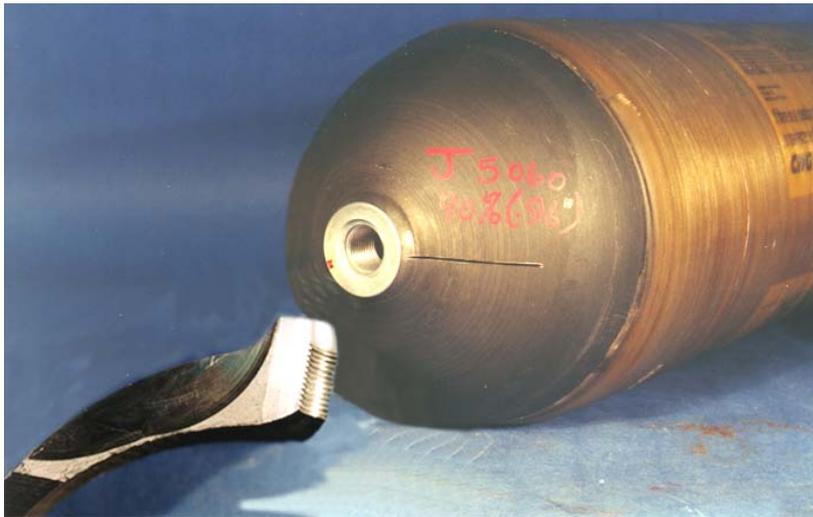
Figure A-18. Photograph shows the location and shape of the external machined flaw (4.0" long [101 mm] and 95% of the neck thickness) introduced onto the neck/shoulder region of an aluminum-lined hoop-wrapped CNG Cylinder Co. cylinder. The cylinder leaked under pneumatic pressurization.

An external defect was machined at the neck area of an aluminum hoop-wrapped cylinder, as shown in Figure A-18. The cylinder, which contained a 4 inch (101 mm) long flaw having a depth of 95% of the neck thickness, leaked at a pneumatic pressure of 167% of service pressure. The flawed cylinder test data under pneumatic conditions demonstrates that the hoop-wrapped designs would leak at the maximum fill pressure, provided that the hoop-wrap is not significantly damaged. In the event of fatigue cracking in the neck/head region, an area not supported by the composite, the design demonstrated a safe failure mode at the maximum fill pressure.

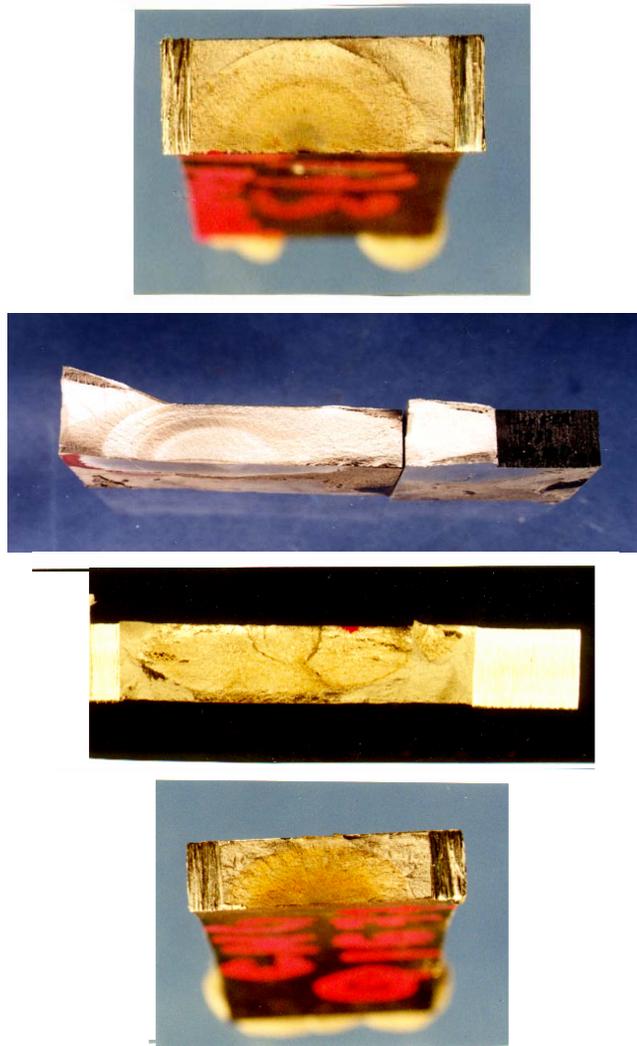
*Figure A-19. Photograph shows size and shape of leak observed during fatigue cycling of the cylinders.
(a) all-steel (Faber)
(b) all-aluminum (Luxfer AA7032)
(c) aluminum lined hoop-wrapped (CNG Cylinder Co.)*

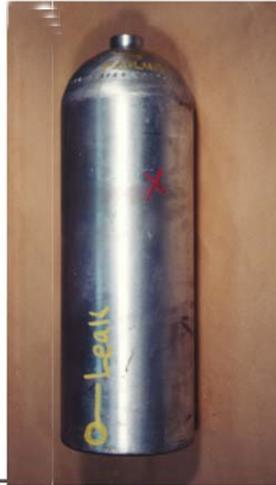
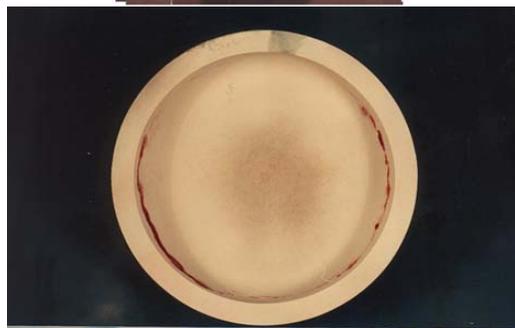
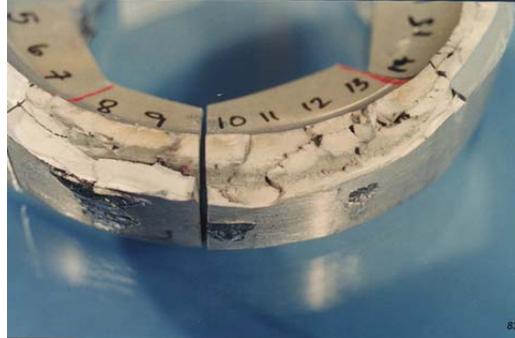
Location and shape of the circumferential fatigue cracking observed for the all-aluminum AA6061-T6 cylinders with flat bottoms are shown in Figure A-20. Even though the internal surface of one of the AA6061-T6 cylinders was scratched prior to cycling, having a depth of approximately 0.01 inch (0.3 mm) at the midsection, the fatigue crack initiated at the bottom of the knuckle and caused a leak after 43,250 cycles under hydraulic pressurization.

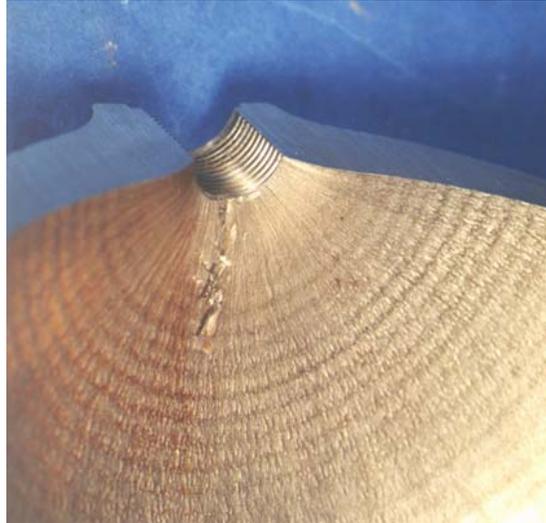
Figure A-21. Photograph shows the location of an internal gouge mark (1.5 inch [38 mm] long and 0.2 inch [5 mm] deep) introduced at the neck area of an aluminum-lined hoop-wrap CNG Cylinder Co. cylinder by cold chiselling method prior to fatigue cycling.

In one of the aluminum hoop-wrapped cylinders pressure cycled to failure, internal defects were introduced by cold chiselling at the neck area on aluminum hoop-wrapped cylinders (as shown in Figure A-21). The chiselled defects were 1.5 inch (38 mm) long and 0.2 inch (5 mm) deep. However, a fatigue crack was initiated at the mid section and became a leak after 27,370 cycles.

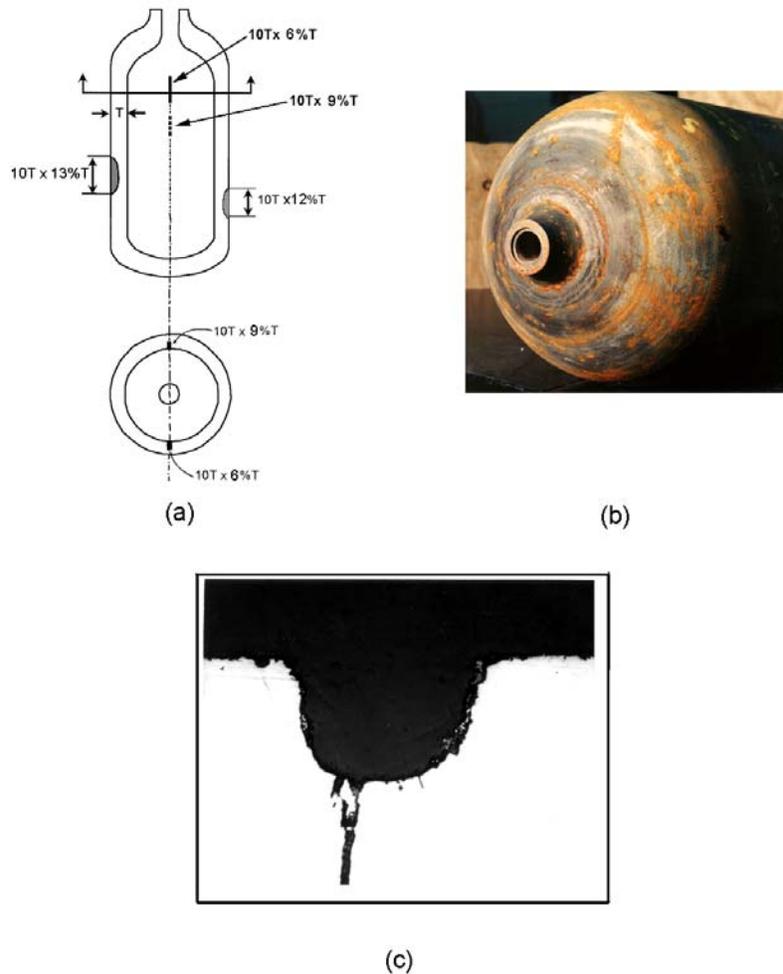
Figure A-22. Faber all-steel cylinder with internal and external EDM flaws:

Four 10T long axial defects, having a depth of 6%T to 13%T (see Table A-7), were introduced onto external and internal surfaces of an all-steel cylinder using the electro discharge machining (EDM) technique. The neck region of the cylinder was modified as shown in Figure A-22a in order to introduce internal EDM defects. Locations of these EDM cuts are shown in Figure A-22b. The cylinder with these four EDM defects was cycled from 300 psi (2 MPa) to 3,750 psi (25.85 MPa) using water. Growth of cracks from these initial external EDM defects was monitored periodically using eddy current methods, while growth of cracks from internal EDM defects was monitored using ultrasonic test methods. After 5,000 pressure cycles a crack was initiated only from the deeper (9%T) internal defect. NDE measurements after 10,000 pressure cycles indicated crack growth from the remaining three initial EDM defects. However, a fatigue crack initiated from the shallower internal EDM defect (6%T) at a later stage became a leak after 15,647 cycles. The shape of the EDM defect which caused the leak is shown in Figure A-22c.

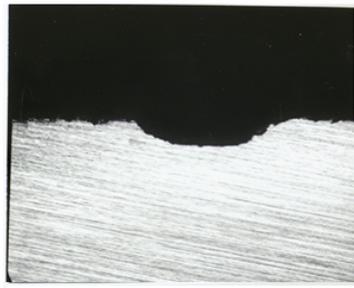
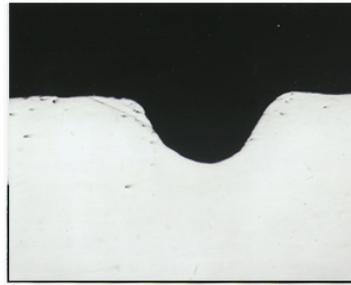
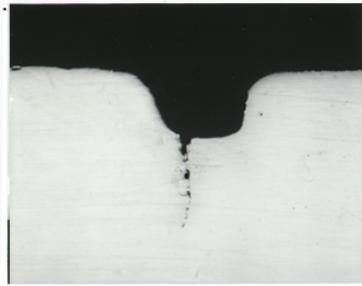
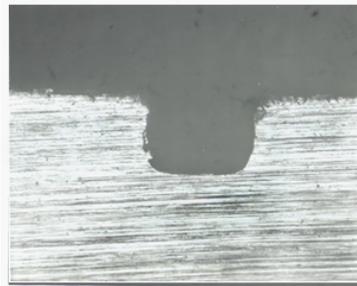
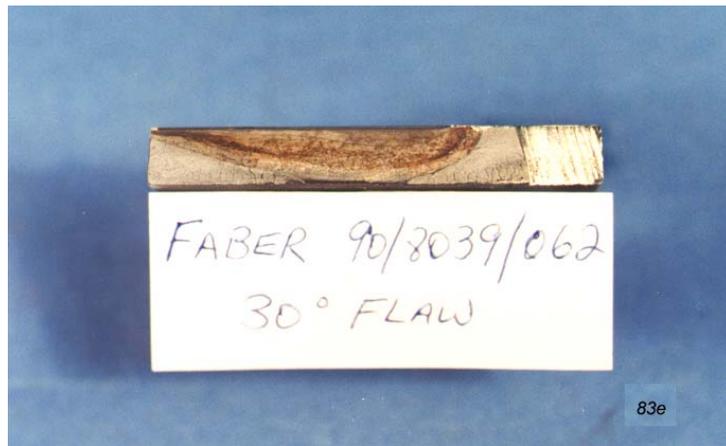
Figure A-23. Shape of the different 3 to 6% deep external defect introduced on an all-steel cylinder by various machining techniques: (a) by grinding; (b) using a 45° cutter; (c) using a 30° cutter; (d) by EDM method; (e) fracture surface of the leak.

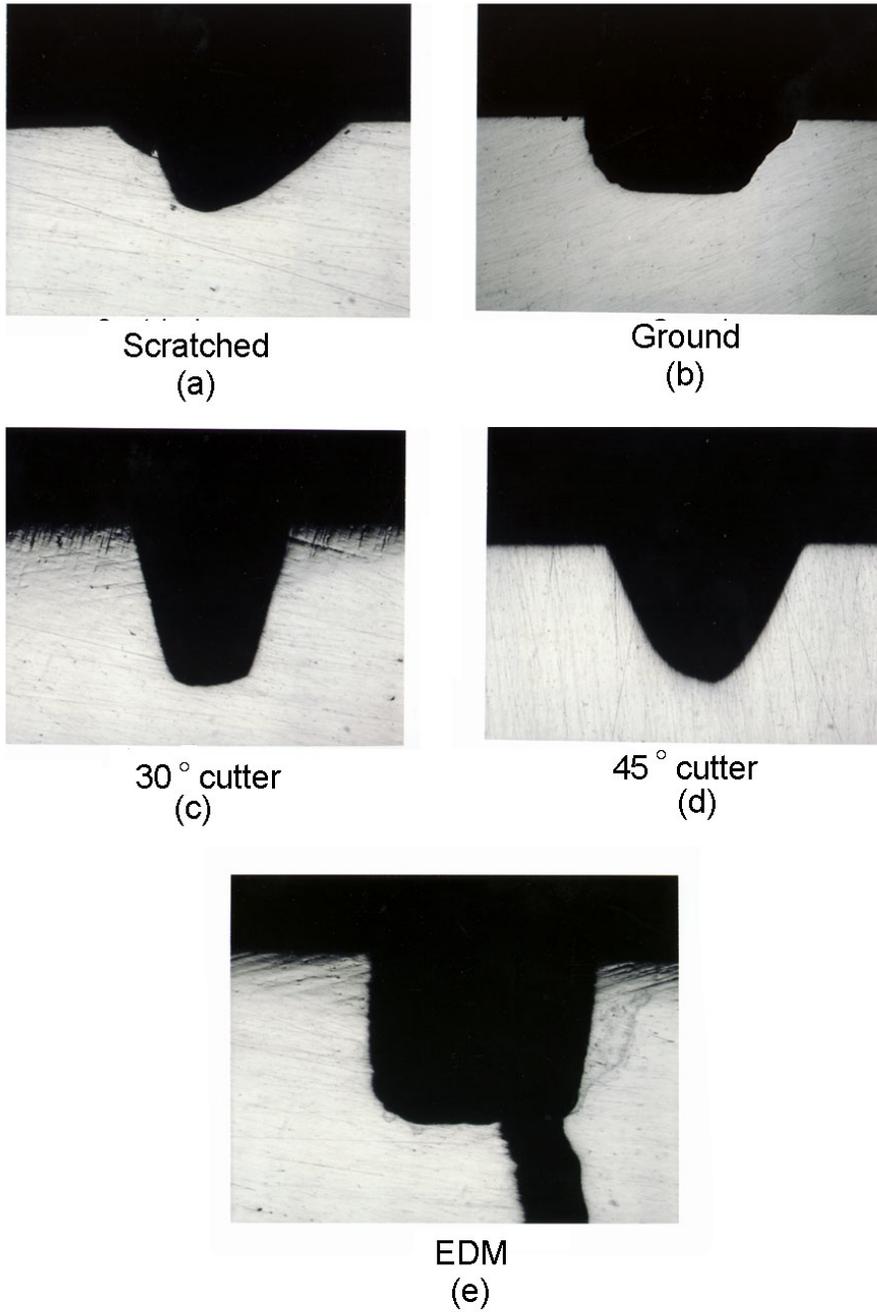
gsb88g1

Figure A-24. Shape of the different 3 to 6% deep external defect introduced on an all-aluminum cylinder by various machining techniques: (a) using scriber; (b) by grinding; (c) using 30° cutter; (d) using 45° cutter; (e) EDM method.

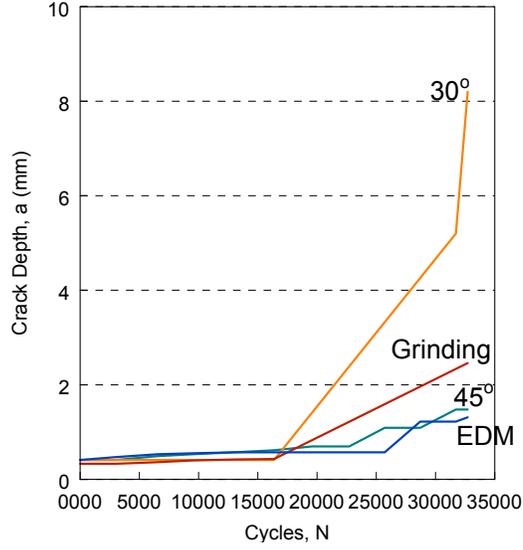
Figure A-25. Growth of fatigue crack from various 2 inch (51 mm) long 3 to 6% deep external defects introduced onto a Faber steel cylinder.

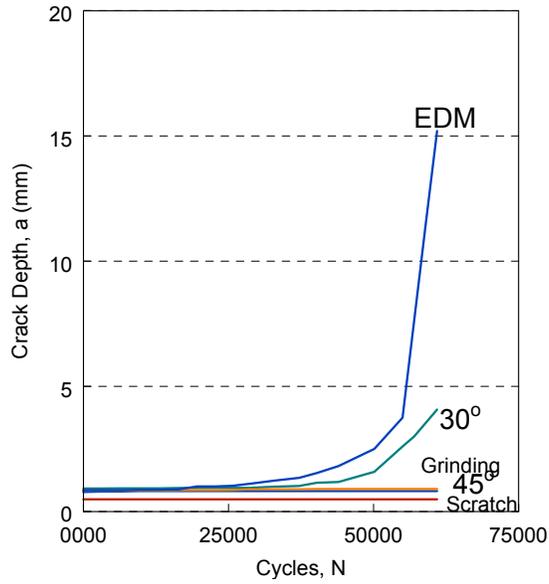
Figure A-26. Growth of fatigue crack from various 2 inch (51 mm) long external defects introduced onto a Luxfer all-aluminum (AA6061-T6) cylinder.

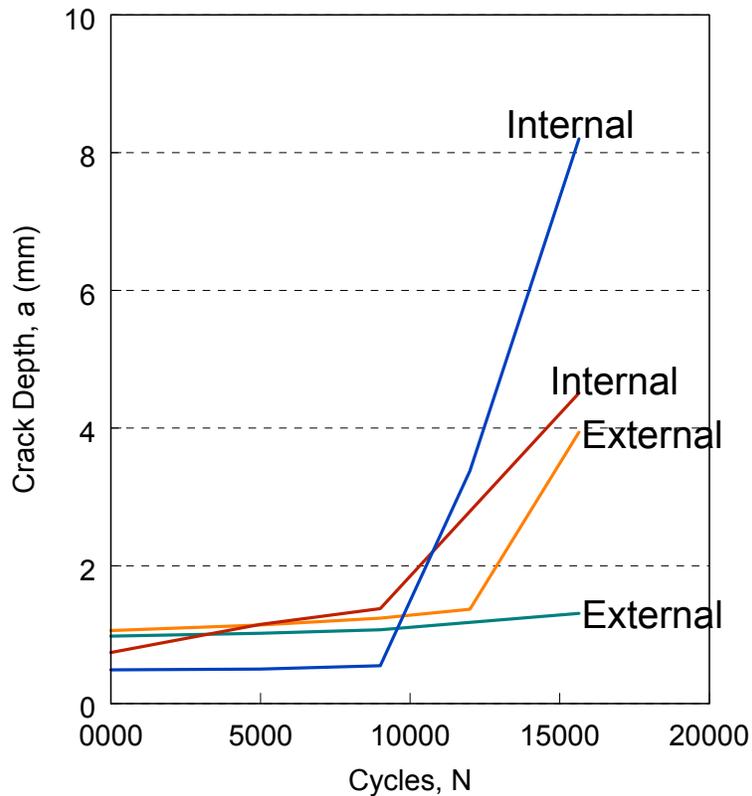
Figure A-27. Growth of fatigue cracks from EDM defects, introduced onto external and internal surfaces of a Faber all-steel cylinder.

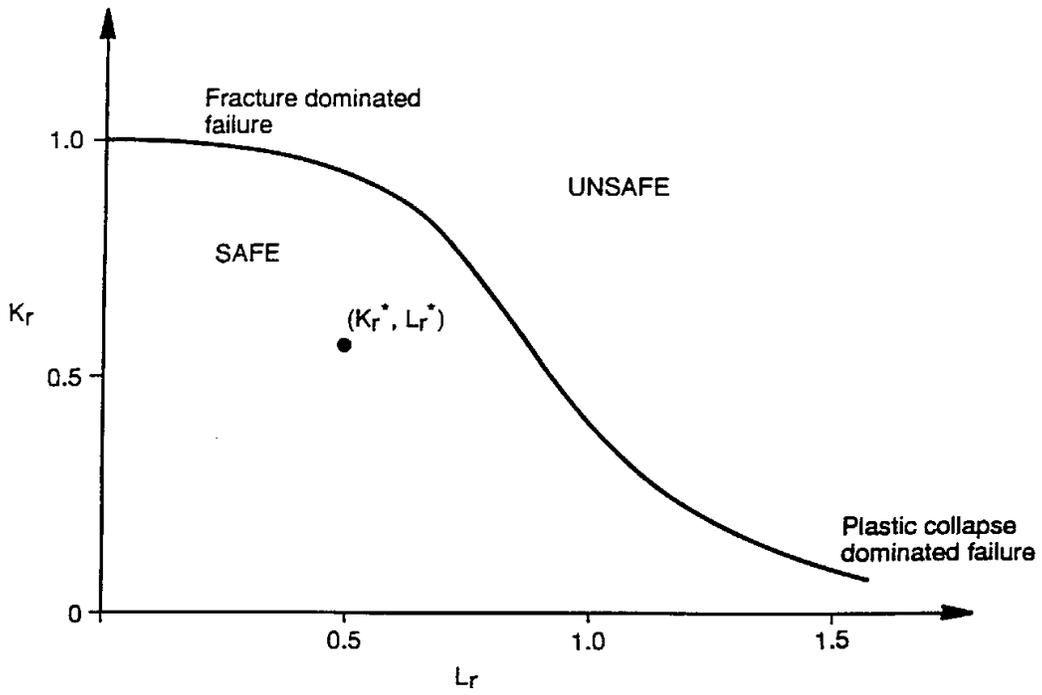
Figure 1-1. Failure Assessment Diagram (FAD) showing safe and unsafe regions.

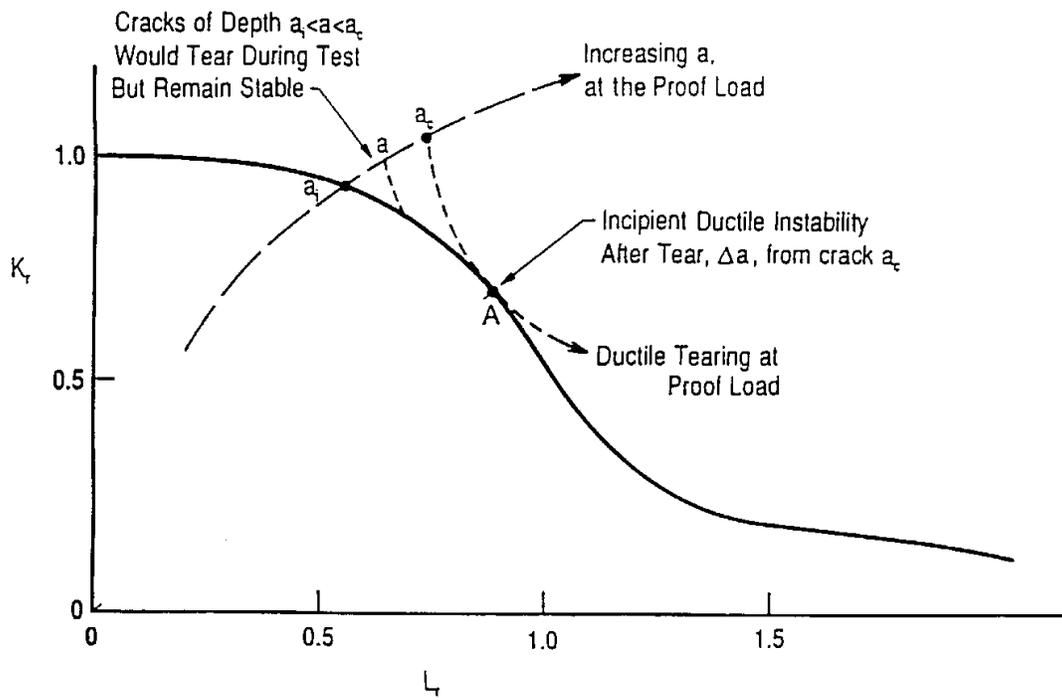
Figure 1-2. Schematic of failure assessment diagram showing calculation of critical crack size.

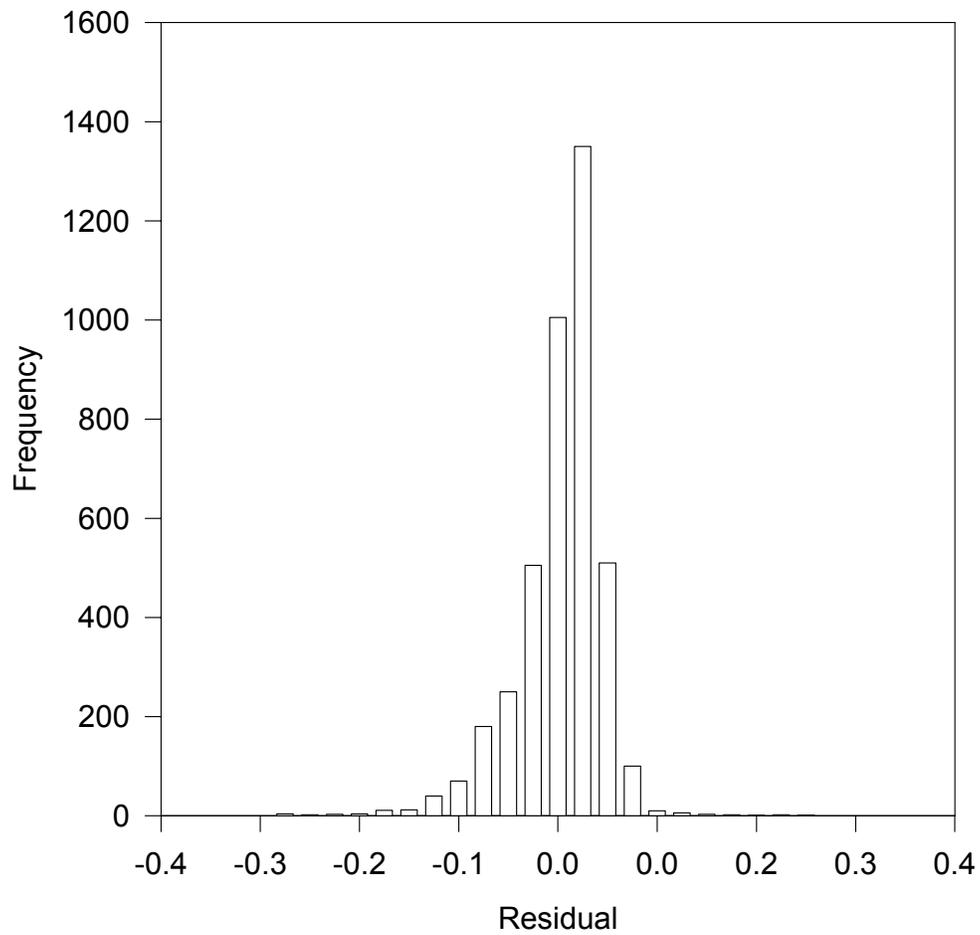
Figure 1-3 Histogram of the residual from final form of the parametric equation. The residual represent the difference between the exact and computed values.
